# Corrosion Resistance of Steel Coated with Different Coating Systems, Containing HAA-Polyester Powder Coating as a Top Layer

This study aimed to assess the impact of surface geometry, preparation, and coating procedures on the corrosion behavior of HAA-polyester powder coated steel components in a salt spray test. The coating process of the steel parts involved degreasing, Zn spray coating, an epoxy powder primer, and a polyester powder topcoat. Results highlighted the crucial role of surface geometry, with flat surfaces showing superior corrosion resistance compared to welded joints, sharp edges, or hollow cylinders. For standard flat panels, no red rust was observed for over 600 hours in the salt chamber, meeting ISO 12944-6 requirements. However, non-standard panels with complex geometries showed rust much earlier, particularly after 108 hours in welded zones and sharp corners when an epoxy primer was not used. Applying the primer extended corrosion resistance by 2-3 times. Hollow cylinders developed rust after 240 hours due to insufficient coating thickness inside the cylinders. Crevices remained vulnerable, as the coating did not reach inner parts. Applying powder to individ

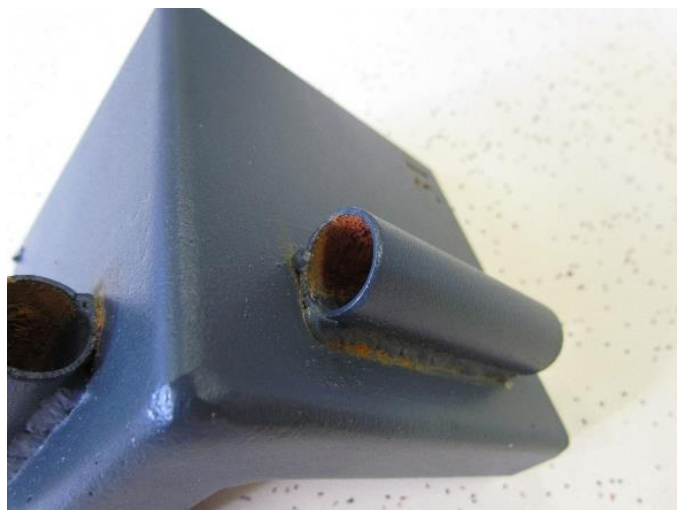
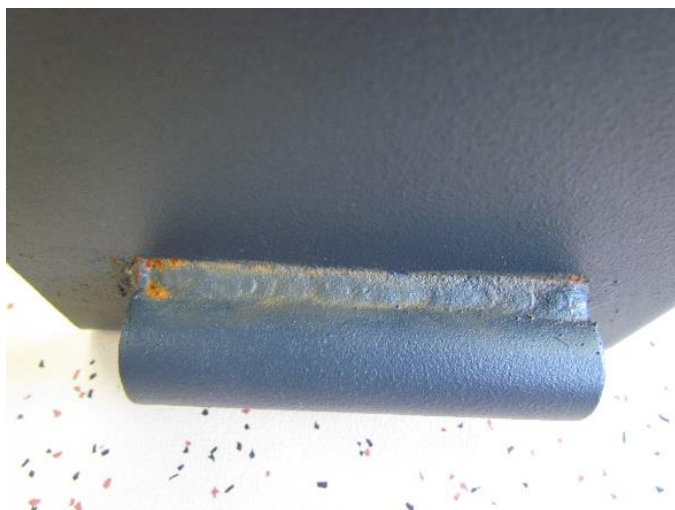
**Figure 2.** Sample No. 18 appearance after 240 hours in the salt chamber. The degree of rust is marked with 0 in the pipe (more than 50% of total surface corroded), and 6 at the welded zone.

The second group of the testing samples consists of the samples 14 – 18, that contain welded edges, but also the two welded hollow cylinders (Fig. 2). The red rust occurrence was spotted after 240 h exposure of these samples to the salt chamber. However, the flat surfaces remained intact, and the corrosion was observed only on the welded zones and at the inner surface of the cylinder. It is clear that the powder coating may not be properly applied at the inner cylinder surface, indicating that longer application time should be

prescribed when such parts require coating. The influence of different preparation steps may be easily differentiated in this contingent of samples: the samples with no preparation and with degreasing only (designation 14, 15) lasted only 156 h in the salt chamber prior to the appearance of visible corrosion, while the samples with Zn spray layer and with epoxy primer layer, lasted until 240. hour of exposure.

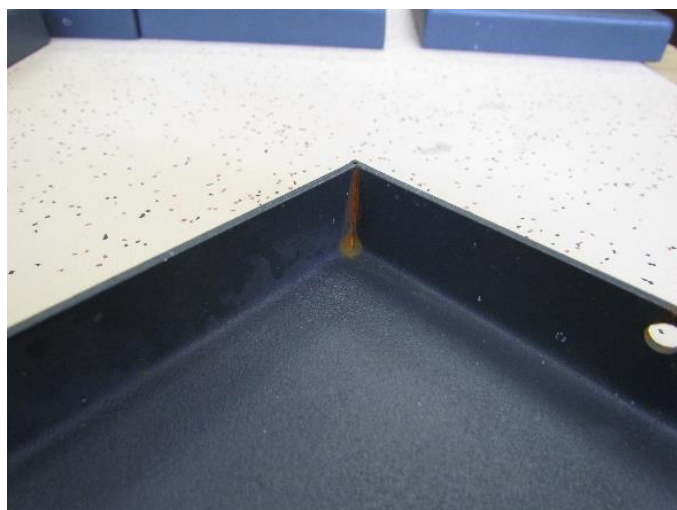
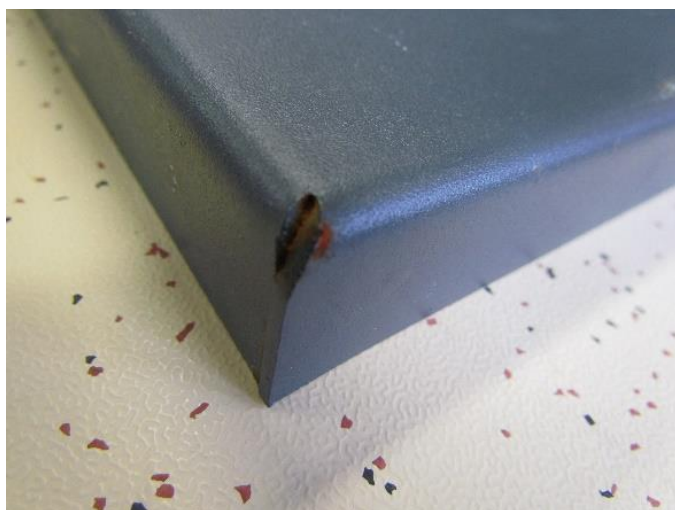
**Figure 3.** Sample No. 6 appearance after 264 hours in the salt chamber. The degree of rust is evaluated with 9, both in the sharp corners and at the edges.

The third tested group belongs to the samples that do not contain welded parts, but do contain rolled edges and corners, i.e. the samples No. 5 – 8. The only regions where the rust occurred at these samples, were sharp edges and sharp corners (Fig. 3). The first reason for this occurrence could be the fact that the powder coating did not cover the sharp corners with sufficient thickness. The second reason is the fact that the sharp corners do not dry so easily as the other part surfaces, i.e. always contain higher amount of the electrolyte from the salt chamber, that is in contact with the coating. This

corrosion type may be characterized as crevice corrosion [9]. Although the rust fingerprint is very similar for all the 4 samples, the time after which this corrosion occurs, differs drastically. For example, for the samples 6 and 8 the rust occurred after 264 hours, for the sample 5 after 348 hours, while the sample 7 lasted the full testing period of 600 hours. One could conclude that the crevice corrosion will definitely start, independently on the preparation and coating process applied, and so the best way of avoiding it, is the avoidance of parts with sharp corners similar to these presented in Fig. 3.

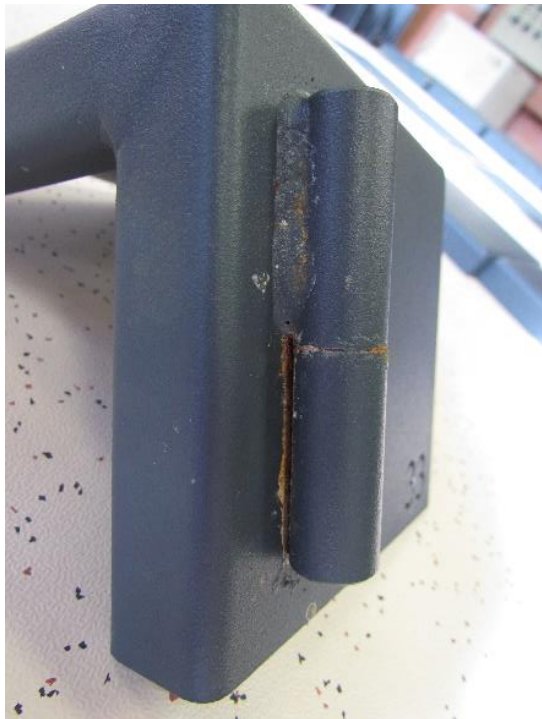
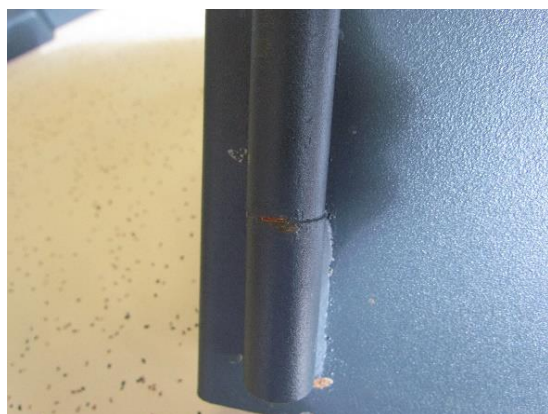
**Figure 4.** Sample No. 20 appearance after 348 hours in the salt chamber. The degree of rust is evaluated with 8 in the welded zone and with mark 3 at the hinge (in the crevice).

The samples with the welded hinge form a very compact group, in sense that all five samples (No. 19 to No. 23) lasted identical time in the salt chamber (348 hours) and that on all of the samples only the crevice corrosion is visible, between

the hinge and the flat metal surface (Fig. 4), as well as the corrosion in the welded zone that is of significantly lower intensity. It is important to stress out that the flat surfaces, the welded corners and the rolled edges remained intact and free

from rust, as it is also depicted in Fig. 4. It is obvious that the surface geometry plays significantly higher role in the protective action of the coating system, than the preparation process: the powder coating system applied may not protect the parts from crevice corrosion, but on the other side successfully protects the flat and rolled surfaces, independently on the preparation process applied, even independently on the fact whether the epoxy primer is present or not.
